LT Murray Wildlife Area
Fish Passage and Diversion Screening
Prioritization Inventory

Habitat Program
Technical Applications Division
Habitat and Passage Projects Section

Washington
Department of
Fish and Wildlife

March 2003

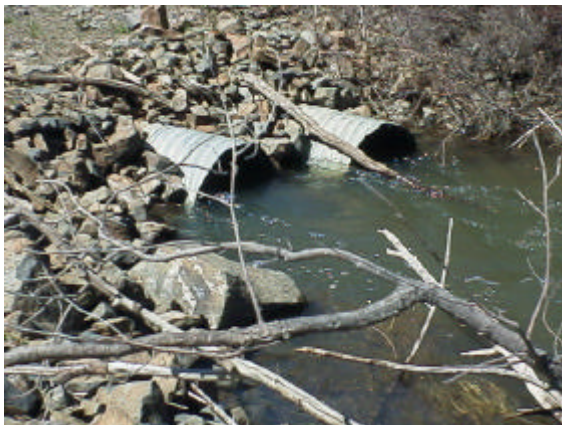
Photo 3. Site 981552 on NF Manastash Creek. Two 0.76 meter diameter culverts are a partial barrier due to velocity and slope.

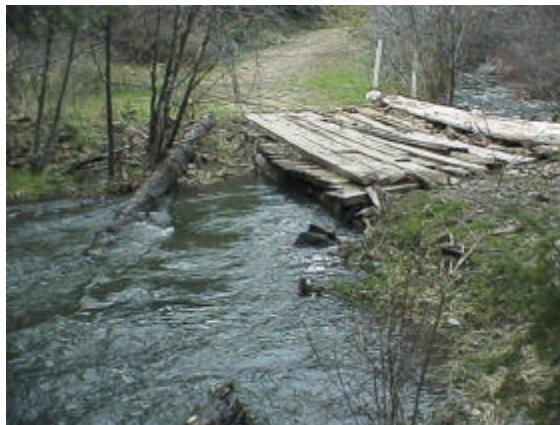
The old bridge, site **981554** (Photo 4), at RM 5.21, is deteriorating but not presently a barrier. Fifteen barriers exist on NF Manastash Creek and tributaries within the WLA. Six more upstream barriers are located west of the WLA on DNR or USFS land.

Photo 4. Site 981554 on NF Manastash Creek. The old bridge is currently not a barrier but is deteriorating.

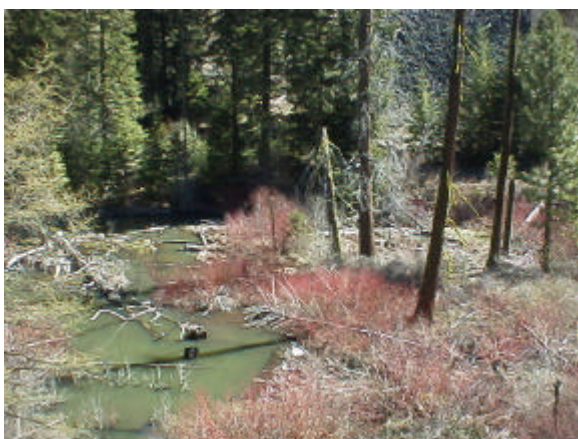
Much of North Fork Manastash Creek suffers from sedimentation. There was little evidence of recent beaver activity and the existing beaver ponds are filling in with sediments (Photo 5). Sedimentation may be attributed to degraded sections of the mainstem, the severely degraded tributaries, and silt released from blown-out beaver dams.

Photo 5. A beaver pond on NF Manastash Creek is filling in with silt. Suspended sediments are evident throughout the stream system.

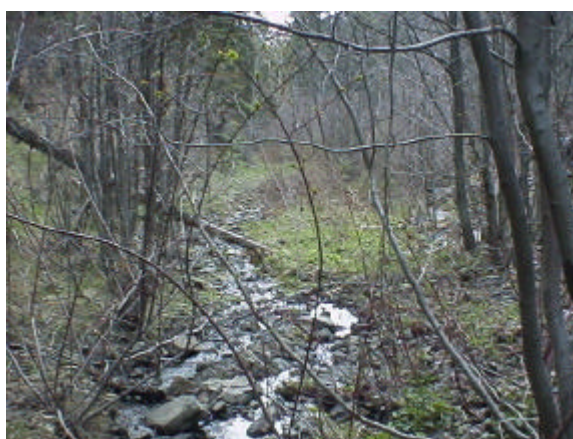
Streambed instability, incisement, debris jams, braiding and flow variations are significantly greater on the tributaries than the mainstem (Photo 6). Logging roads were constructed immediately adjacent to and frequently crossing most of the tributaries. In some sections, debris jams divert the tributary flows onto the roads.

Photo 6. Tributary flow is partially diverted onto an old logging road. Whisky Canyon Creek.

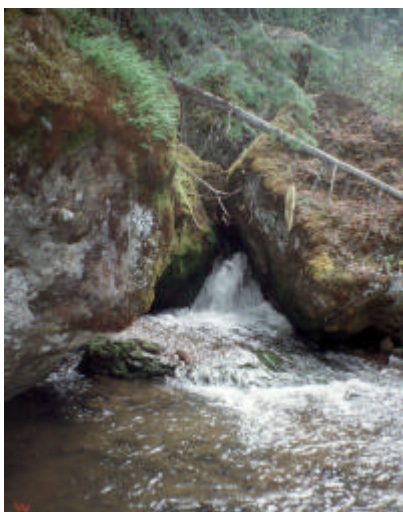
Photo 7. At RM 9.11, on NF Manastash Creek, two very large boulders, spaced about 0.20 meters apart, constrict the stream and create a hydraulic drop. At low flows this may be a barrier to fish.

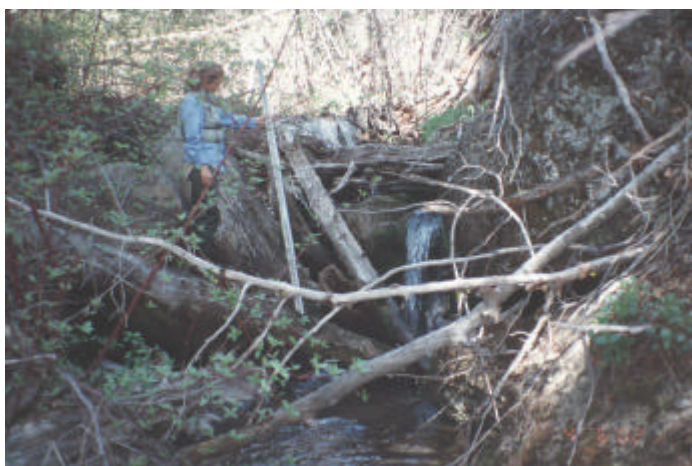
Photo 8. At RM 10.01, on NF Manastash Creek, is a large debris jam that splits the flow into three channels creating hydraulic drops of 1.3 to 2.1 meters. This may be a low flow barrier to fish.

A large boulder and woody debris jam, at RM 9.14, creates a low flow barrier. At RM 10.01 a debris jam splits the stream into three channels with hydraulic drops of 1.3 to 2.1 meters (Photo 8). None of these fish passage problems are total barriers to fish migration, though they may be problems during low flow conditions.

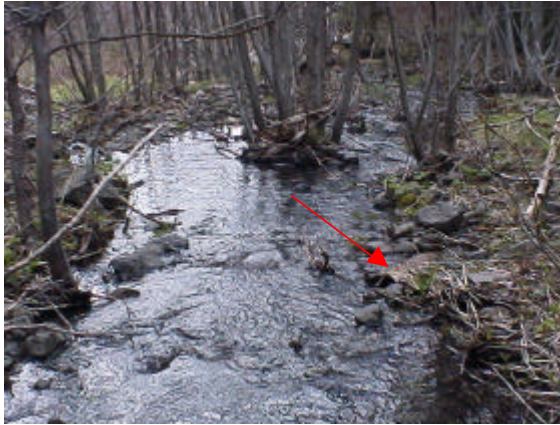
The first culvert encountered at 867 meters upstream of the confluence with NF Manastash Creek, site **981556** (Photo 9), is passable but the culvert is mostly buried and the stream flows around it. Site **981557** (Photo 10), located at 1,098 meters, is a total barrier due to velocity and slope.

Photo 9. Site 981556, located 867 meters upstream on Whisky Canyon Creek, is passable. The red arrow points to the nearly buried culvert along the right bank.

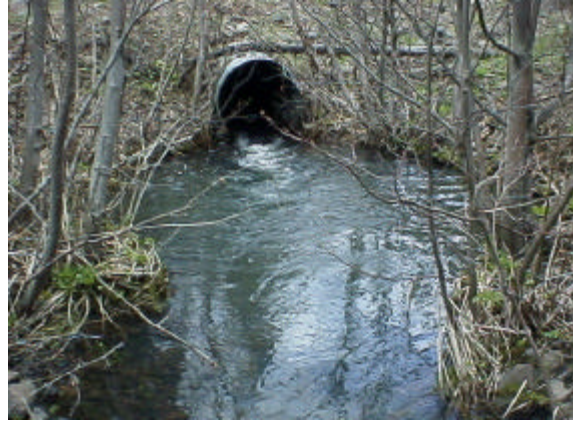
Photo 10. Site 981557, on Whisky Canyon Creek, is a 0.76 meter diameter culvert. This undersized culvert is a total barrier due to velocity and a 6% slope.

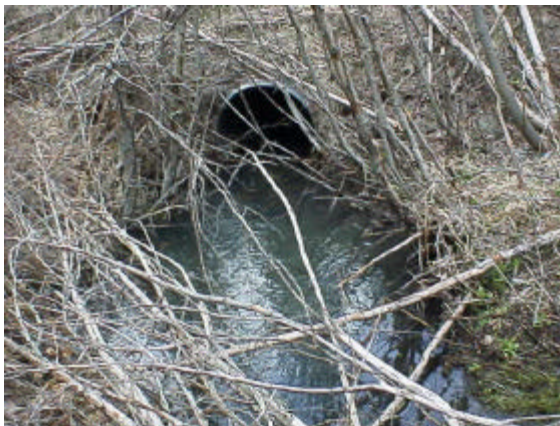
Site **981558** (Photo 11) at 1,525 meters, is a partial barrier due to velocity and slope. Site **981565**, (Photo 12), at 1,673 meters is a total barrier due to outfall drop and insufficient water depth in the culvert.

Photo 11. Site 981558, on Whisky Canyon Creek, is a 0.76 meter diameter culvert that is a partial barrier due to velocity and slope.

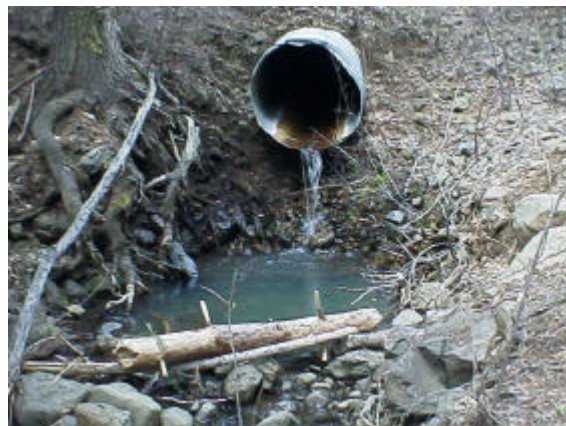
Photo 12. Site 981565, on Whisky Canyon Creek is a 0.91 meter diameter culvert, is a total barrier due to outfall drop and water depth.

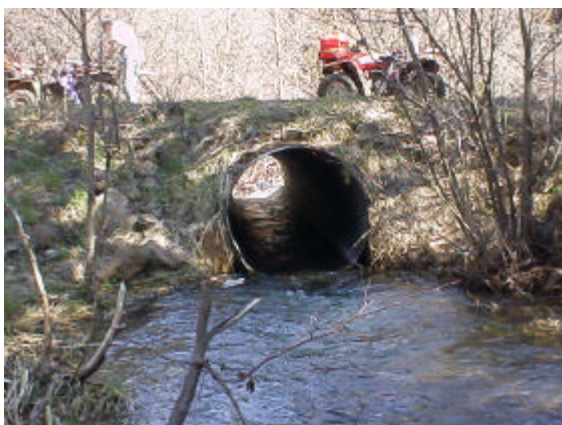
WDNR site **T18R16E-12** (Photo 13), at 51 meters upstream, measures 1.07 meters in diameter. This culvert is a partial barrier due to insufficient water depth. WDNR site **T18R16E-6** (Photo 14), a barrier due to outfall drop and velocity, is located 224 meters upstream. These two barrier culverts are on DNR managed land. A 5.18 meter high falls ends anadromous fish habitat at 1,200 meters upstream.

Photo 13. Site T18R16E-12 on Bear Canyon Creek, is a 1.07 meter diameter culvert just 51 meters upstream of the confluence with NF Manastash Creek. WDNR evaluated this site as a barrier. A barrier falls ends anadromous fish access at 1,200 meters upstream.

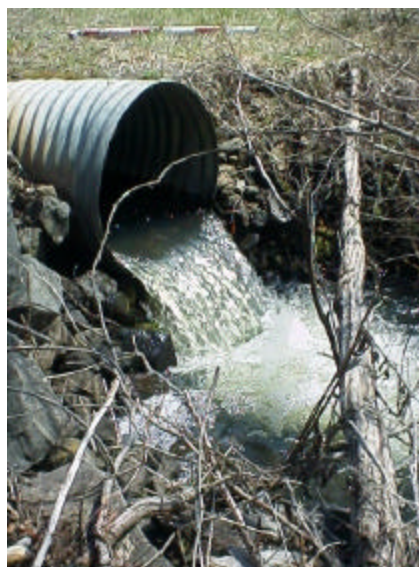
Photo 14. Site T18R16E - 6, on Bear Canyon Creek, is a 0.76 meter diameter culvert, 224 meters upstream of the confluence with NF Manastash Creek. WDNR evaluated this site as a barrier.

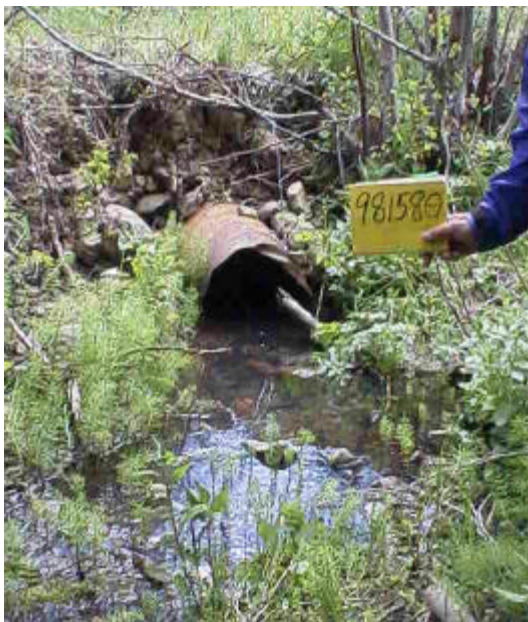
Photo 15. Site 981580 features a 0.46 m diameter culvert which is a partial barrier due to velocity and slope. This culvert is 701 m up a right bank tributary to NF Manastash Creek.

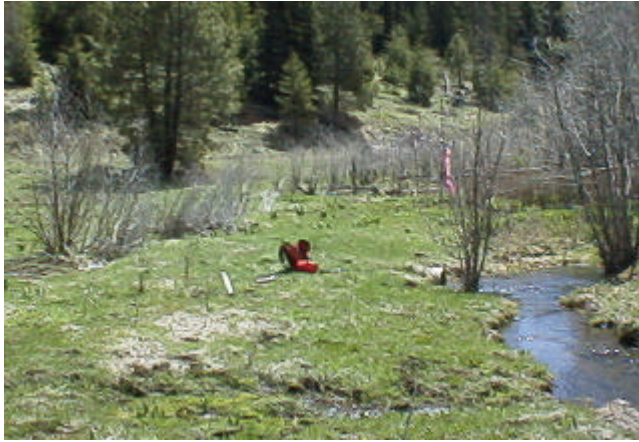
Photo 16. Site 981570 is located 586 meters up an unnamed tributary to NF Manastash Creek. The 0.46 m diameter culvert is a partial barrier due to slope and velocity.

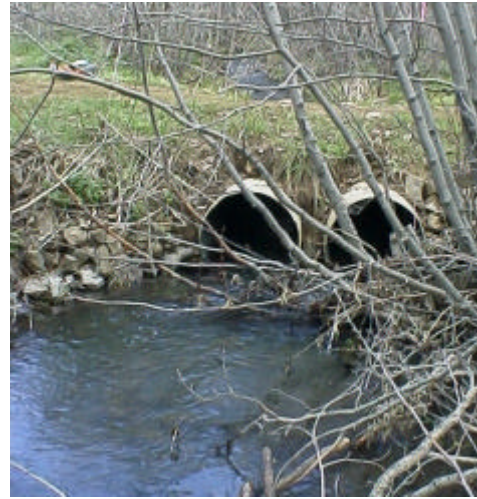
passage, site **981571** (Photo 17). Site **981575** at 2,588 meters features a dam with a passable cascade overflow .

Photo 17. Site 981571, is 944 meters upstream on an unnamed tributary to NF Manastash Creek. A pair of 0.61 m diameter culverts create a partial barrier due to a 4.6% slope. This site is on Murray Road.

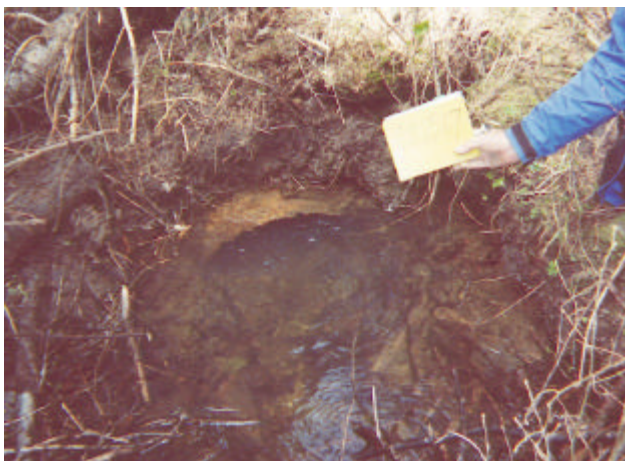
Photo 18. Site 981567, a 0.46 meter diameter culvert. Partial barrier due to slope. Unnamed tributary to NF Manastash Creek.

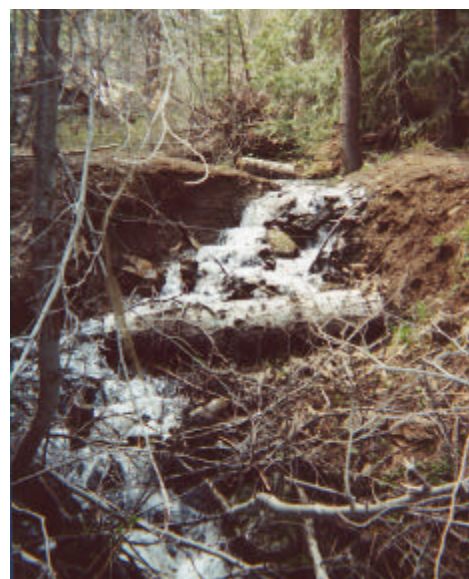
Photo 19. Site 981568, a ford crossing eroding the road. Unnamed tributary to NF Manastash Creek.

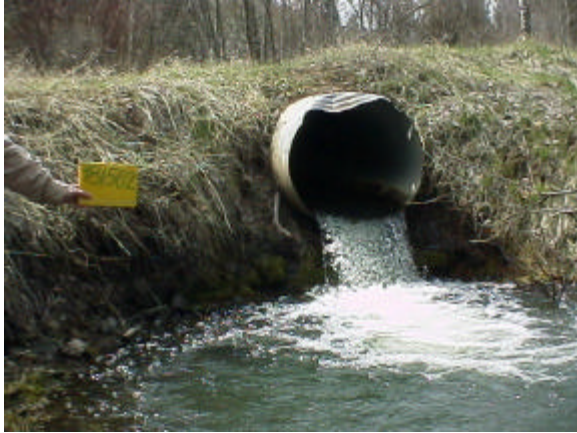
Photo 20. Site 981502 is the first barrier encountered on Robinson Creek in the WLA. This 1.07 m diameter culvert is a total barrier due to a 0.58 m outfall drop, and a 3% slope. This feature has the second highest PI value, 24.20.

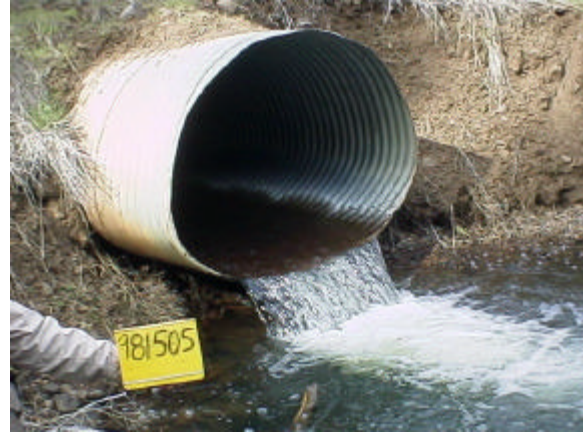
At 3,158 meters, site **981505** (Photo 21), is a squash culvert which is a partial barrier due to outfall drop. The PI value is 20.71 and the potential habitat gain is 11.0 kilometers of stream with 5,953 square meters of spawning and 9,789 square meters of rearing habitat.

Photo 21. Site 981505, on Robinson Creek, is a 1.75m squash culvert. It is a partial barrier due to a 0.36 m outfall drop and a 4.8% slope. The PI value for this site is 20.71.

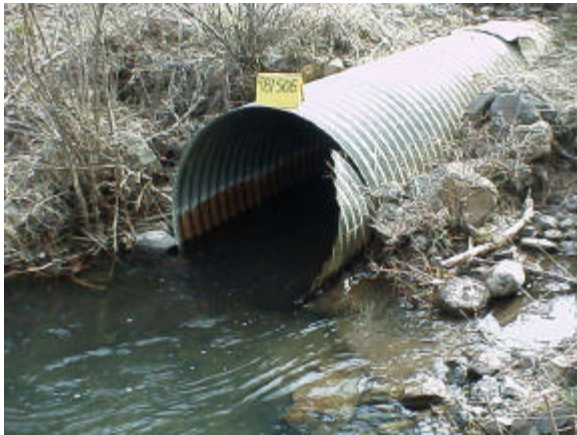
Site **981506** (Photo 22), is a 0.91 meter diameter culvert. This culvert is a partial barrier due to slope and velocity. At 6,288 meters the stream forks. The right fork contributes 95% of the flow and the left fork, considered the mainstem, is nearly dry. Fish were observed up to this point. WDNR site **T18R16E-11**, at 6,354 meters is a 0.91 meter diameter culvert that is a total barrier due to outfall drop and slope. Flow is now intermittent and fish use is unknown. The mainstem survey continued to the end of potential fish use, 7,900 meters upstream of site 981501.

Photo 22. Site 981506, on Robinson Creek, is a 0.91 m diameter culvert that is a partial barrier due velocity and a 2.6% slope. The PI value for this site is 17.17.

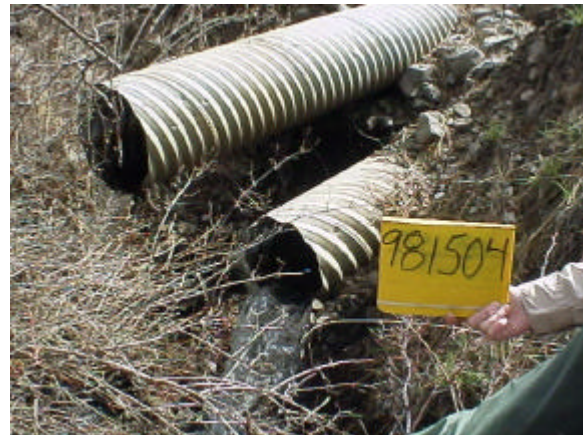
Photo 23. Site 981504, at the mouth of Ainsley Creek, has a pair of perched culverts that are a total barrier to fish passage. This site blocks fish access to 3.2 km of stream.

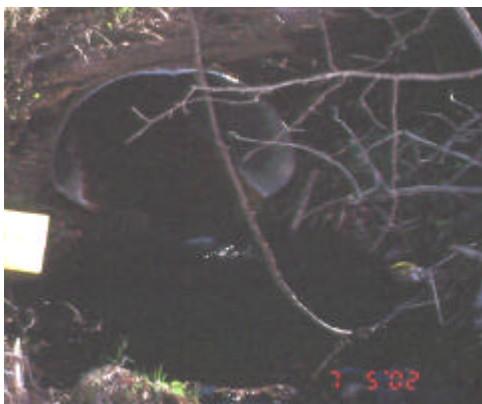
Potential habitat gain is 1,656 square meters of rearing and 371 square meters of spawning. At 1,710 meters, site **981521** (Photo 24), a 1.62 meter squash culvert is a partial barrier due to slope. Site **981522** (Photo 25), at 2,203 meters, consists of a 0.61 meter diameter culvert and a 0.91 meter diameter overflow culvert. This feature is a barrier due to slope and velocity.

Photo 24. Site 981521, on Ainsley Creek. This 1.62 m squash culvert is a partial barrier due to a 5.7% slope.

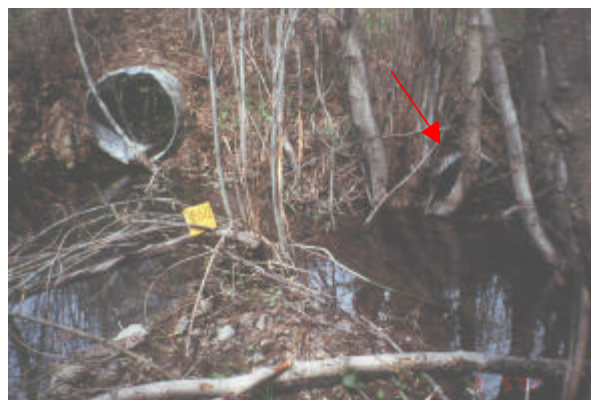
Photo 25. Site 981522 on Ainsley Creek. The red arrow points to a 0.61m diameter culvert. The culvert on the left is a 0.91m diameter overflow culvert.

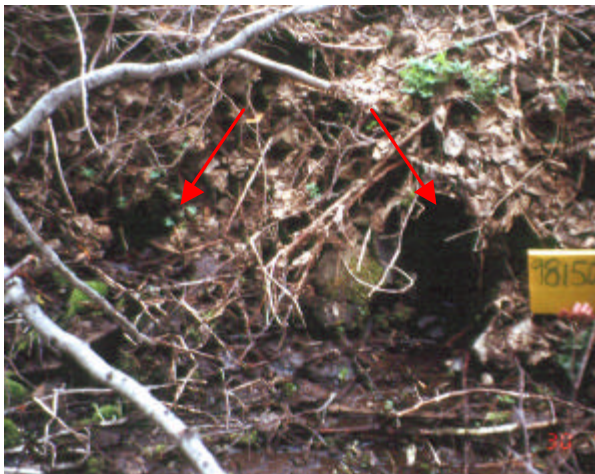
channel a short distance downstream. This site looks like a ford crossing and the culverts are difficult to find. Stream gradient ranges from 3.5 to 7%. Canopy and instream cover are good. Limiting factors are lack of habitat complexity, low summer flow, severe scour and sedimentation.

Photo 26. Site 981508 is located on a right bank tributary to Robinson Creek. This pair of 0.46 m diameter culverts are buried at the upstream end, but a small amount of flow seeps through. Most of the stream flows over the road and rejoins the stream channel a short distance downstream.

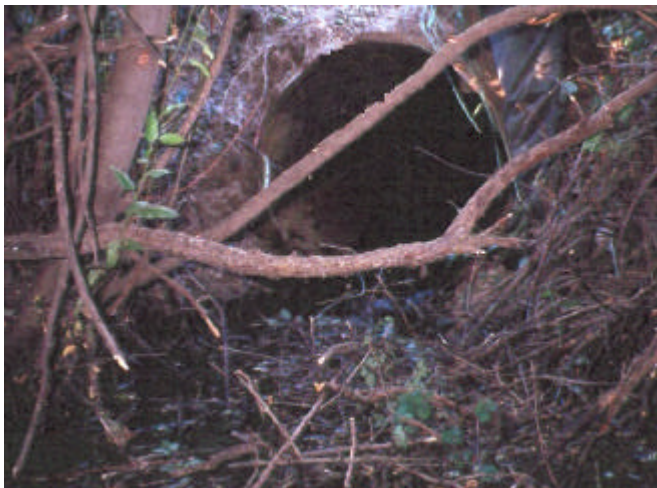
Photo 27. Site 981514 is located on Joe Watt Creek where it crosses Hutchins Road. This 0.76 m diameter culvert is a partial barrier due to slope.

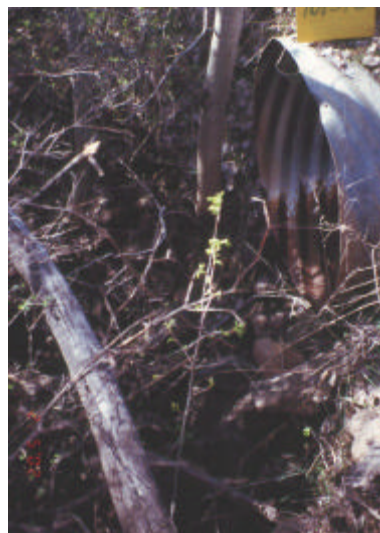
Photo 28. Site 981513 is 2,014 m upstream of the Hutchins Road crossing. This 0.76 m diameter culvert is a total barrier due to slope and outfall drop.

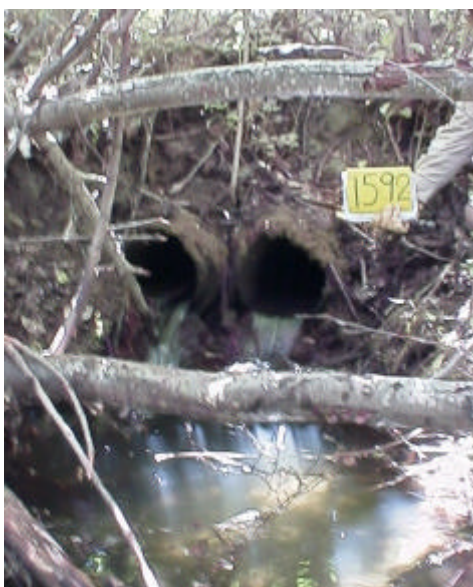
Photo 29. Site 981592, on Yahne Creek, is a pair of 0.31m diameter culverts. This is a partial barrier due to slope and velocity.

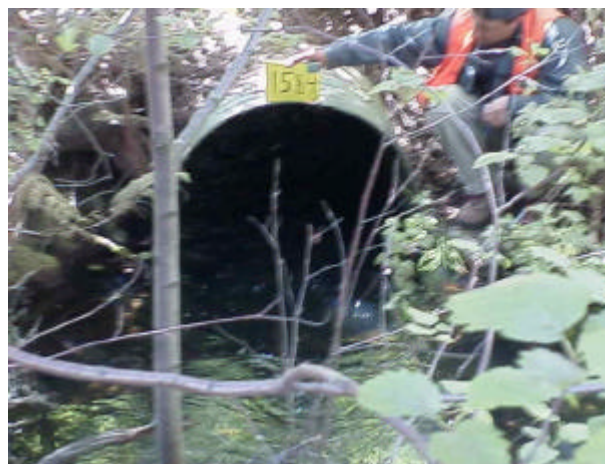
Photo 30. Site 981519, on Shadow Creek, is a 0.91m diameter culvert that is a total barrier due to a 5.5% slope and velocity.

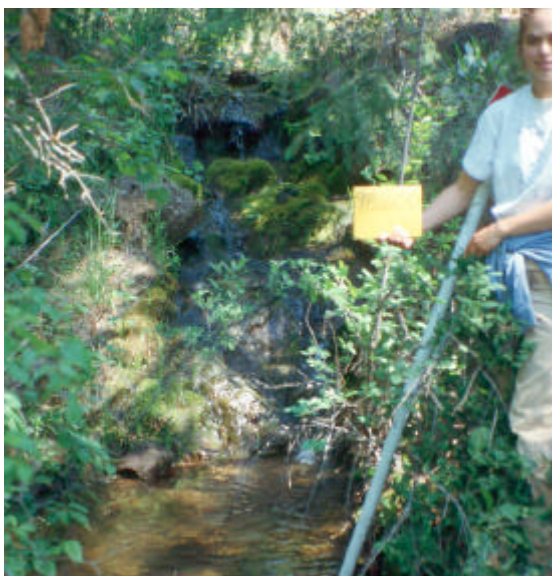
The pond outlet channel is 110 meters long and gradient ranges from 1 to 7% with a natural bedrock cascade (Photo 31), 1.5 meters high, near the end. This cascade is the reason site 981600 is a barrier.

Photo 31. Site 981600 on Morrison Canyon Creek features a dam with an overflow channel 110 m long. This 1.5 m high cascade on the overflow channel is a low flow barrier.

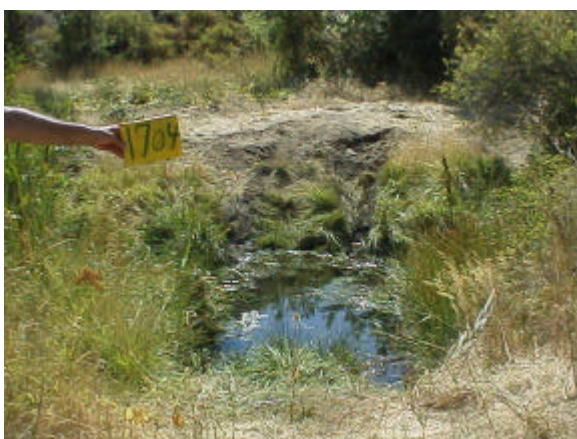
Although all the ford crossings are passable, they do impact fish. For instance, site **981704** (Photo 32) contributes fine sediments from bank erosion. This picture was taken after a hunter's truck recently negotiated the crossing. Many fords are steep and soils are loosened as vehicles' spinning tires churn up the banks.

Photo 32. Site 981704 on Quilomene Creek, is a passable ford crossing but unstable banks contribute fine sediments to the stream. This picture was taken after a hunter's truck recently negotiated the crossing.

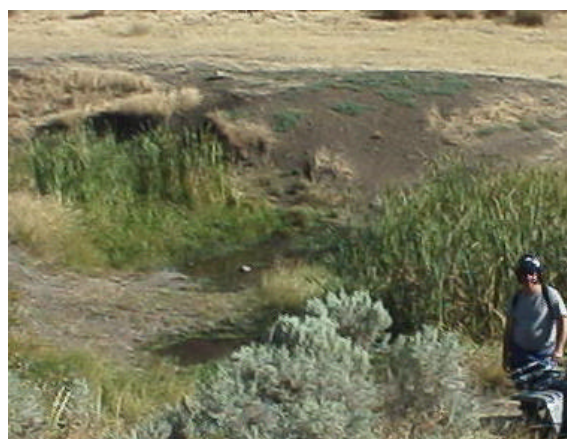
Photo 33. Site 981699, on Hunt Creek, also a passable ford crossing. Fords tend to cause the stream to become wider, shallower and rutted making fish passage difficult during low flows.
